WHOI-87-54

Technical Activities Associated with the ZONAL Pacific Array

George H. Tupper

Technical Report

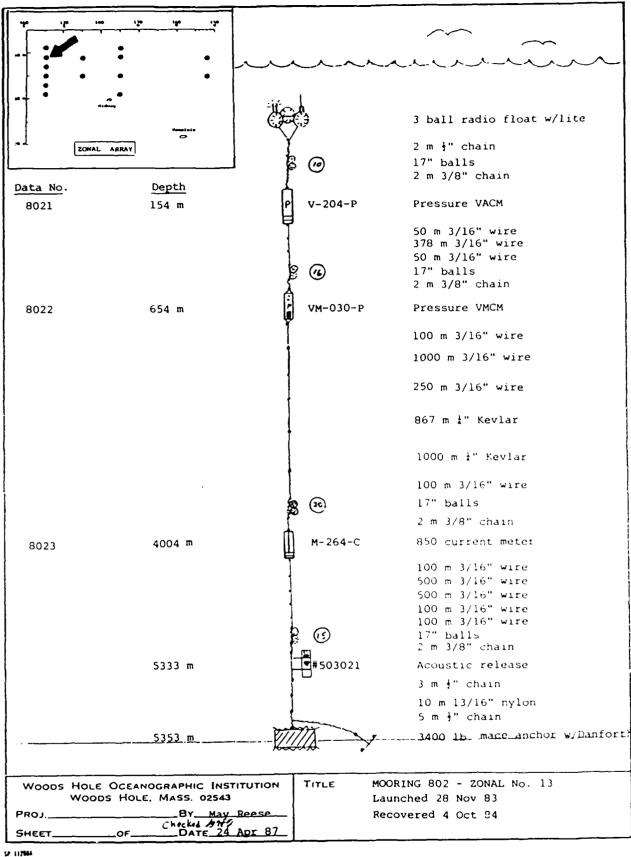
Fig. 2 Typical WHOI Intermediate Mooring

The WHOI Buoy Group has been making in situ current velocity measurements in the ocean since 1960. The majority of these measurements are made from subsurface, intermediate moorings. The term "intermediate" refers to the fact that flotation, in the form of clusters of glass balls, is distributed along the mooring at intermediate depths as well as at the top. The balls are distributed in such a way that if a component fails, there is sufficient buoyancy remaining below the failed component to allow recovery of the remainder of the mooring without dragging. moorings for the ZONAL experiment except two were of this type (Fig. 2). The remaining two moorings were similar in design to the intermediates, but the upper flotation consisted of a syntactic foam sphere with 2,000 pounds of buoyancy. The sphere provides the same buoyancy as 40 glass balls with one-seventh the drag, thus improving the performance of the mooring in high currents. Since high currents were anticipated at two mooring sites in the western part of the array, sphere moorings were used at those sites. Figure 3 illustrates the sphere mooring.

The WHOI Buoy Group moorings are constructed of off-the-shelf components. The upper 2000 meters of the mooring uses wire rope to minimize damage that could result from fish attack. The depth range and effects of fish bite on mooring lines have been documented by Berteaux and Prindle (1987). The wire rope used in the 20NAL moorings was 3/16 inch in diameter, jacketed with

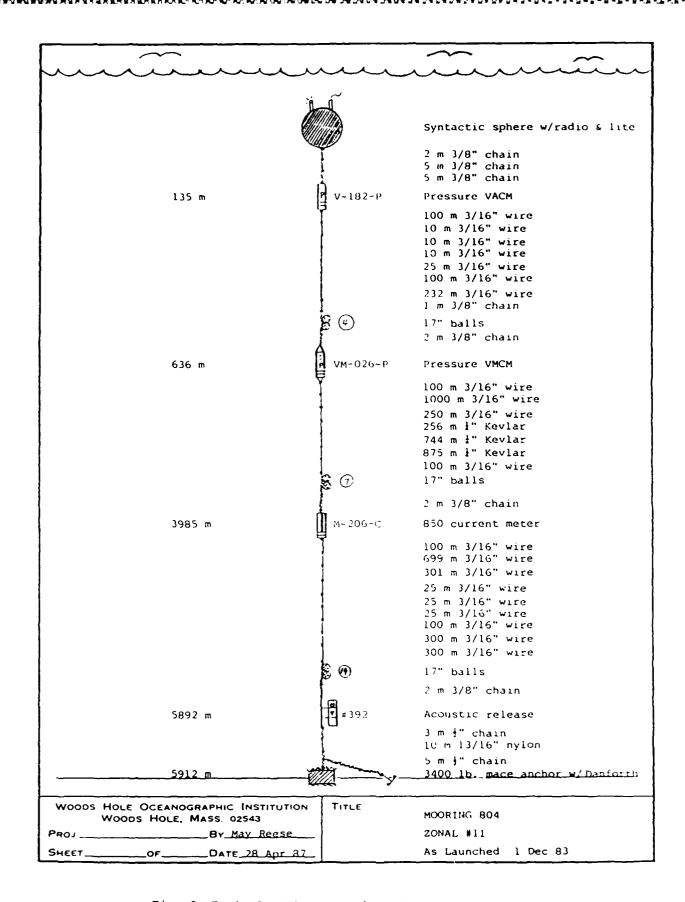
Fig. 3 Typical WHOI Syntactic Sphere Mooring

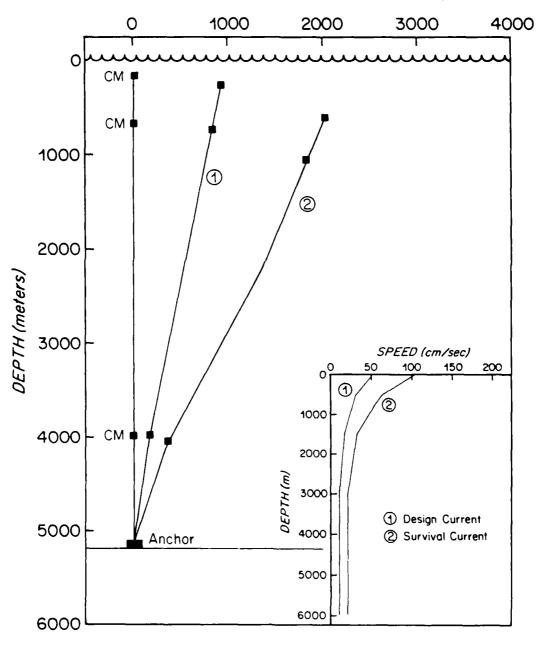
ZONAL MOORING NO. 2 PERFORMANCE

Fig. 4 Intermediate Mooring Performance - Eastern Current Profile

A computer program entitled NOYFB (Moller, 1976) is used to design each mooring. This program mathematically constructs the mooring to the designer's specifications, subjects it to various current profiles, and predicts resultant performance. Two current profiles are usually tested. The first, or design current, represents the currents that the mooring will experience most of the time and must perform well in. The second is the worst case current profile that the mooring must be able to survive. Figures 4-6 show predicted performance of selected moorings from the array.

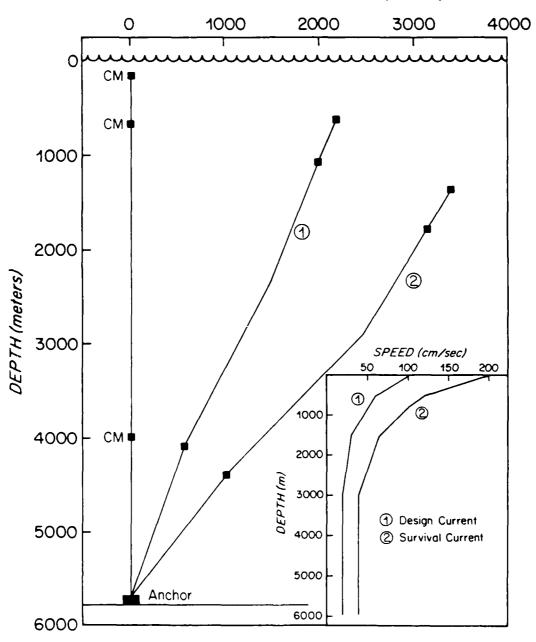
ZONAL MOORINGS 9 & 10 PERFORMANCE

Fig. 5 Intermediate Mooring Performance - Western Current Profile

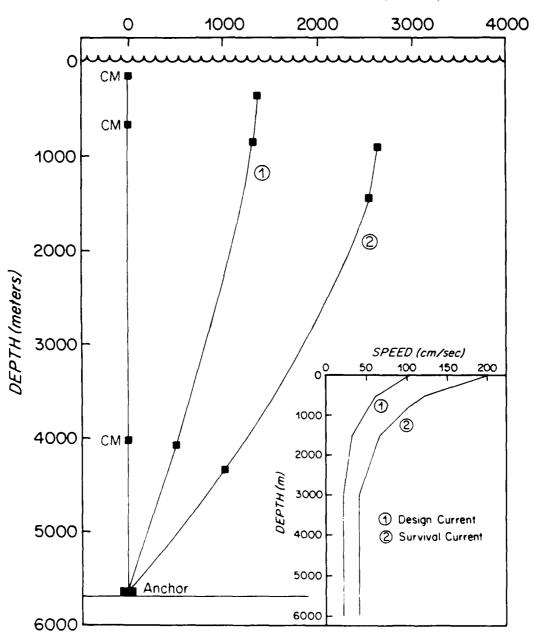
ZONAL MOORING NO. 11 PERFORMANCE

Fig. 6 Syntactic Sphere Mooring Performance - Western Current Profile

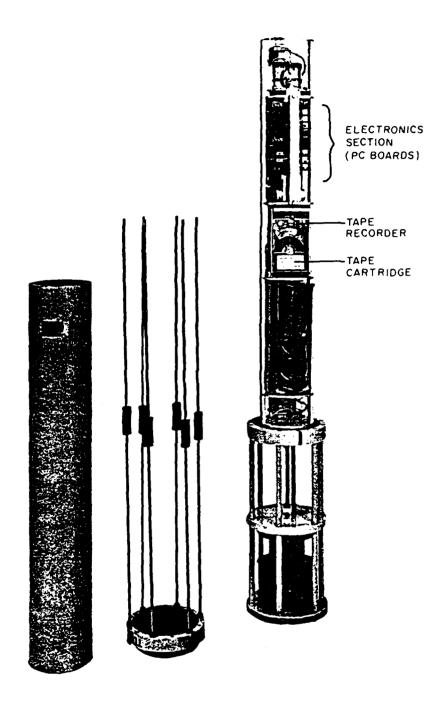
The 850 current meter (Fig 8) measures current flow using a Savonius rotor and a direction-sensing vane, both mounted in a protective cage below the electronics and battery housing. The pressure housing, made of 7075-T6 aluminum, has an inside

Fig. 8 Geodyne 850 Current Meter

diameter of 6 inches and a wall thickness of 1/2 inch, allowing deployments to a maximum pressure of 8,000 pounds per square inch (about 5300 meters). Maximum tensile load across the instrument is 5,000 pounds.

The Savonius rotor is an omnidirectional, cylindrical sensor which rotates about a vertical axis in response to the water flow. Sixteen magnets are equally spaced around the outer perimeter of the top plate of the rotor. As the rotor turns, a magnetic reed switch above it closes each time a magnet passes. The switch closures are counted for a specific time interval, 5.191 seconds, giving the rotation rate.

The vane senses the current direction with respect to the instrument housing. Two parallel magnets are fitted to the top of the vane, and spaced equidistant from the center of rotation.

Two parallel magnets with the same spacing from the center of rotation are enclosed in a fluid-damped vane follower inside the pressure case. They are magnetically coupled to the vane and free to rotate, "following" the vane. The vane follower's position is decoded by a 7-bit analog-to-digital converter, giving the direction of current flow with respect to the instrument housing.

The housing's orientation with respect to magnetic north is measured by an internal fluid-damped, gimballed compass mounted in the top of the instrument. The compass position is also decoded by a 7-bit analog-to digital converter. The sum of the compass and vane readings is the direction TO WHICH the current is flowing (as opposed to conventional wind measurements. In which the wind is measured FROM a particular direction).

Water temperature is measured by a thermistor, a device whose electrical resistance varies with changes in temperature. Mounted on the bottom end plate of the instrument housing, the thermistor senses the temperature of the end plate. The end plate does not change temperature instantaneously with the temperature of the water but has a time constant of about two minutes.

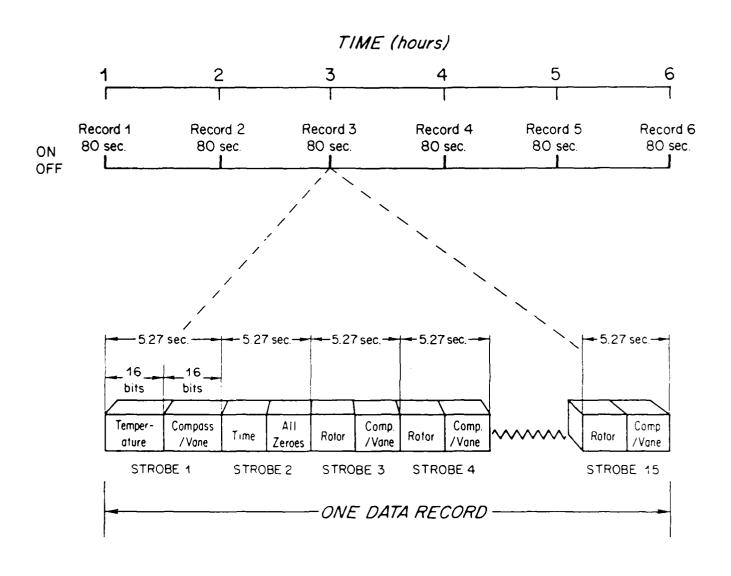
Fig. 9 Data Format, 850 Current Meter

word. The time word is a binary value whose least significant bit has a weight of 15 minutes, the most significant bit representing 85 days and eight hours. Before deployment, the clock is reset to all zeroes at a known time. This time is logged on the data sheet. The clock counts up from the all zeroes condition, incrementing by one count each fifteen minutes. The burst sampling rate has no effect on the time word, i.e. if the record rate is one hour, the clock word will advance by 4 each record, indicating that one hour, or four 15-minute bits, has elapsed since the last recording cycle. If the record rate is 15 minutes, the clock word will increment by one, indicating that 15 minutes has elapsed since the last data record. The time word on tape indicates the time at which the current meter began its 80 second data recording cycle. Later, during the data processing, the "time of observation" of each record is adjusted to fall in the center of the 80 second sample period. For strobes 3 through 15, the format reverts to rotor-compass-vane, each set (strobe) sampled once every 5, 27 seconds.

The 850 is a burst-sampling current meter, meaning that a short burst of data is recorded periodically. The length of the burst, and the number of bursts sampled per unit time determine how long the instrument will run. The battery, consisting of four strings of 8 alkaline "D" cells, supplies enough energy to record a full data tape regardless of the sampling scheme selected. For this experiment one burst was recorded each hour, on the hour. The burst length was 80 seconds. The data record, or burst, for this experiment was composed of 15 "strobes" of data, gathered at the rate of one strobe each 5,27 seconds (Fig. 9). Each strobe contains thirty-two bits of information, divided into two 16-bit fields, the first of which is "rotor", the second is "compass/vane". The first two bits of each 16-bit field are zeroes, which leaves 14 bits in each field for data. The first two strobes of each record are unique. The rotor field of the first strobe of each record contains a fourteen bit temperature word; the second strobe rotor field contains the 14 bit time

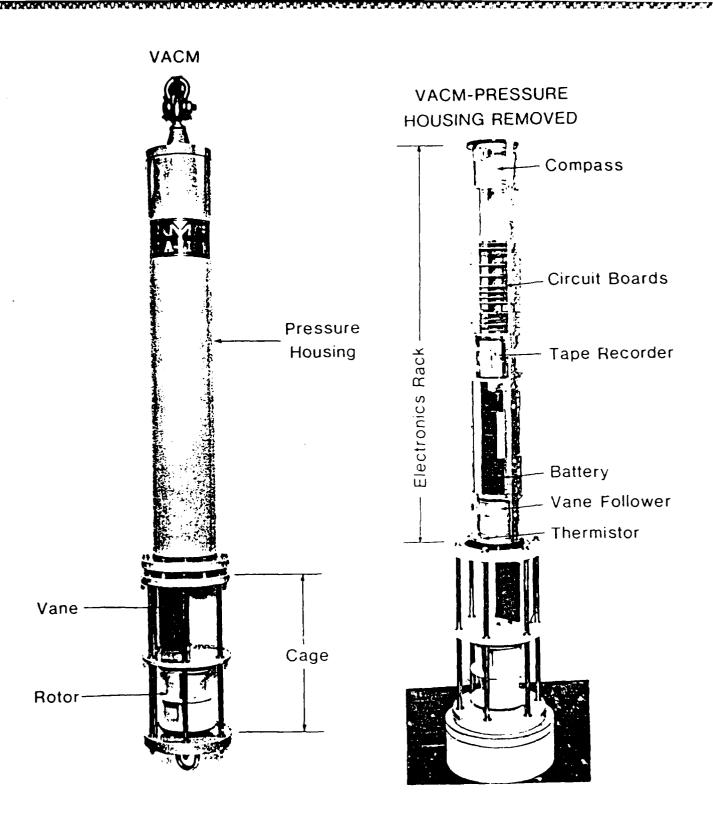
The VACM (Fig. 10), designed at WHOI, uses the same vane and Savonius rotor as the 850. The instrument housing and the rotor/vane protective cage assembly, however, are much stronger, allowing a 10,000 pound tensile load across the instrument, compared to 5,000 pounds for the 850. The pressure housing, made of 7075-T6 aluminum, has an inside diameter of 6 inches and a wall thickness of 3/4 inch, allowing deployment to a maximum pressure of 10,000 pounds per square inch (about 6,700 meters). Inside the pressure case, the VACM compass and vane follower are similar to those used in the 850. They are housed in aluminum cases, however, and contain no damping fluid. Damping is accomplished by the eddy currents of the moving magnets interacting with the aluminum housing. The analog to digital conversion of the compass and vane readings still utilizes a 7-

Fig. 10 Vector-Averaging Current Meter (VACM)

bit converter, but with solid-state components capable of very high interrogation rates. The compass or vane follower can be read at rates up to 100,000 times per second.

The rotor motion is sensed by a magneto-diode rather than a mechanical reed switch. The magneto-diode is a solid-state device whose resistance to electrical current flow changes when a magnetic field is close by. The 16 magnets on the top rim of the rotor are oriented with alternate north and south poles on the outside edge. Each time a north and south magnet passage is sensed, the current meter begins a computation cycle. In other words, each time the rotor rotates one-eighth of a turn, corresponding to the passage of 4.6 cm of water, the instrument goes through a cycle which reads the compass, reads the vane, and adds the two numbers to get a resultant flow direction for that 4.6 cm water parcel. The vector computer then converts the direction from polar coordinates to cartesian coordinates, resulting in a signed value of x and y, or east and north, for the direction of that parcel of water. These values are stored in the east and north memory registers, respectively, completing the data cycle. On the next 1/8 turn of the rotor, the cycle repeats, and the new values of east and north are added to those already in the storage registers. This summing process continues over a specific time interval, called the record interval - in the ZONAL experiment, 15 minutes (except for the two-year VACMs, which had a record rate of 1/2 hour). At the end of the record interval, the sums are written to tape, the East and North registers are reset to zero, and the process begins again.

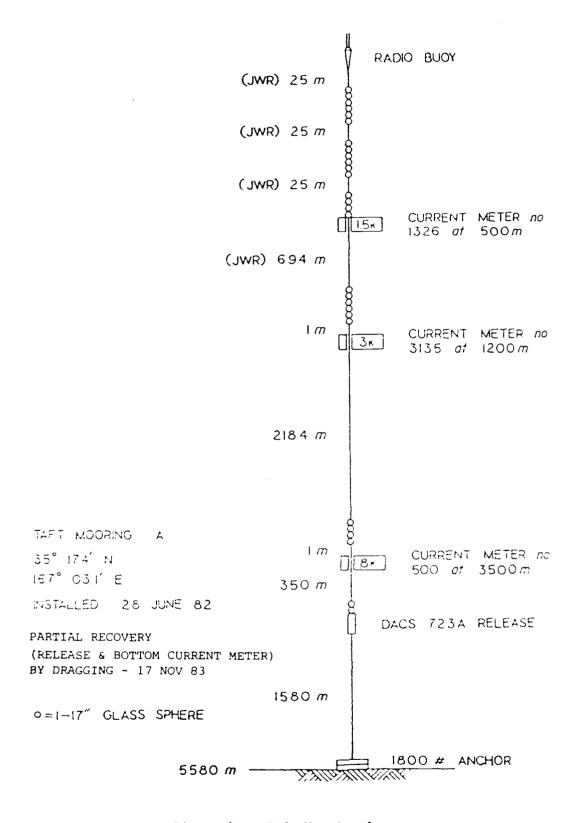
Figure 12 Taft Mooring A

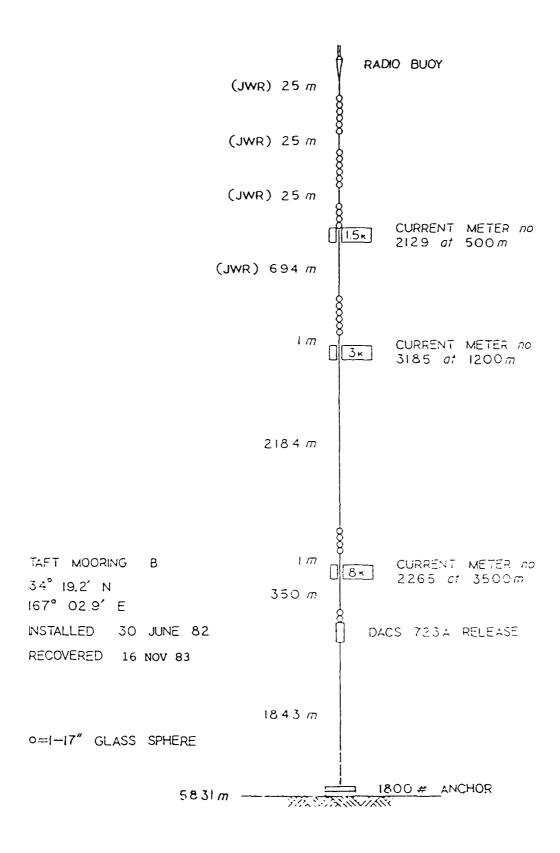
Figure 13 Taft Mooring B

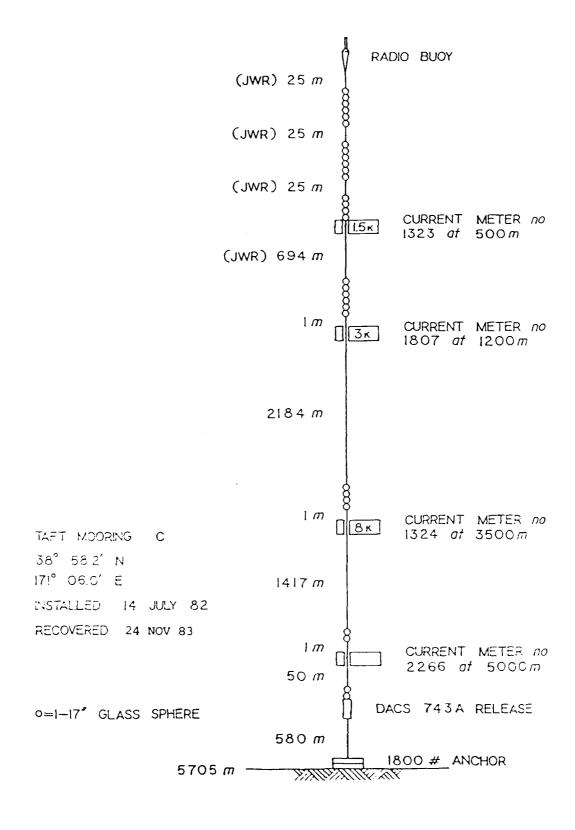
Figure 14 Taft Mooring C

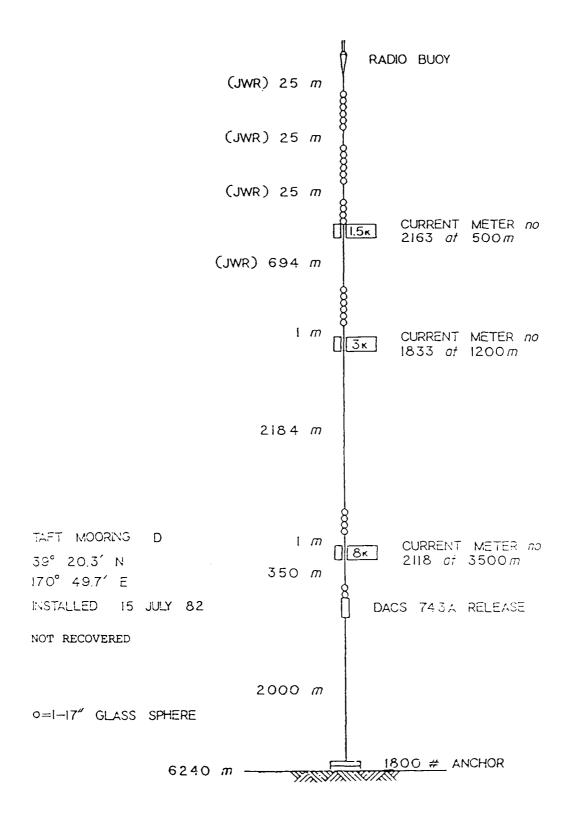
Figure 15 Taft Mooring D

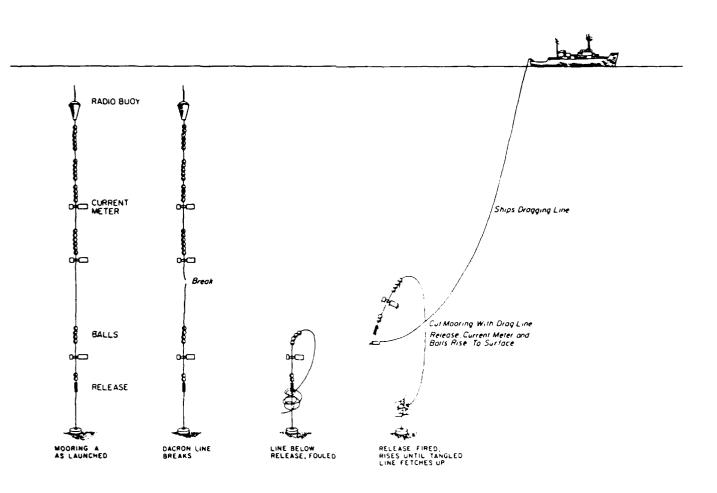
Fig. 16 Taft Mooring A failure and dragging procedure

that the mooring had parted somewhere in the 2,184 meter dacron section and the remainder of the dacron had fallen to the sea floor, tangling with the line below the release (Fig. 16). When the release fired, the glass balls remaining pulled it up until it fetched up on the tangle.

The decision was made to drag for the mooring using the trawl wire. The drag was successful, and proved the failure mode was as suspected - the line below the release was fouled with dacron from above the current meter. Recovered items were the release, one current meter, and six glass balls.

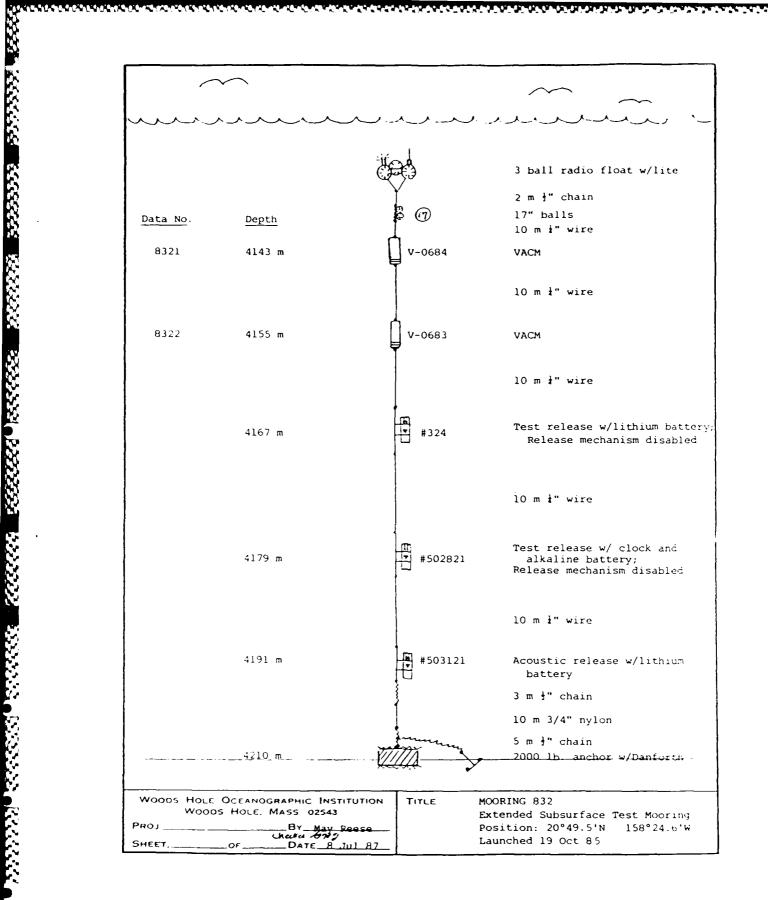
Fig. 19 Extended Duration Subsurface Mooring

The decision to use two-year moorings at the eastern part of the array was based on several factors. In the early planning stages the mooring cruises were to be in and out of either Honolulu or Midway Island. The location of these two moorings would have required several extra days of ship time to transit to the site in order to turn the moorings around at the one year point. By utilizing the two year mooring design which had been developed and was in the process of being tested, a considerable savings could be experienced. Test results in hand in early 1983 indicated a high probability of success for two-year deployments of subsurface moorings. This array was the first opportunity to use this new capability.

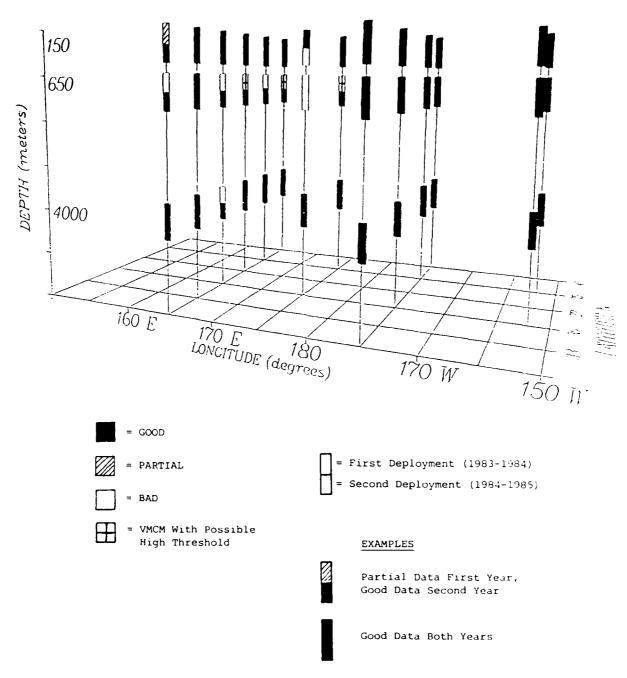
Fig. 21 Data Return, ZONAL Pacific Experiment

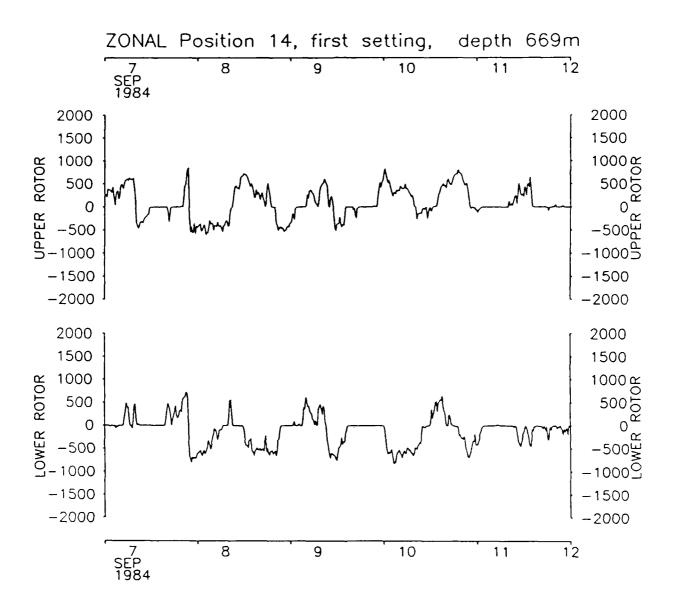
The first group of Vector measuring Current Meters recovered from the ZONAL Pacific Array presented several unique problems. Three of the instruments experienced flooded stings and four others had rotor problems characteristic of missing counts (Fig. 22, 23). Figure 23 is a typical VMCM time series; note the smooth transition through zero for Rotor 1 and Rotor 2. Figure 22 is a time series from ZONAL I; note the disconinuity about zero.

Fig. 22 A VMCM data record from the first year's ZONAL deployment (1983-1984)

array exhibited several electro-mechanical problems, most of which were related to the sting assembly. An analysis of the hub assembly indicated the possibility of inadequate O-Ring compression between the window and the face as well as an interference fit between a foil run on the Sony board and the shoulder on which it rests. This contact resulted in the Sony signal being shunted to ground with a corresponding loss in rotor counts. The interference problem is aggravated with depth. As the ambient pressure increases the likelihood of contact increases. Of the seven instruments recovered from ZONAL I, three had shallow-water leaks in the sting, one main housing leaked, and the remaining three had rotor dropout problems.

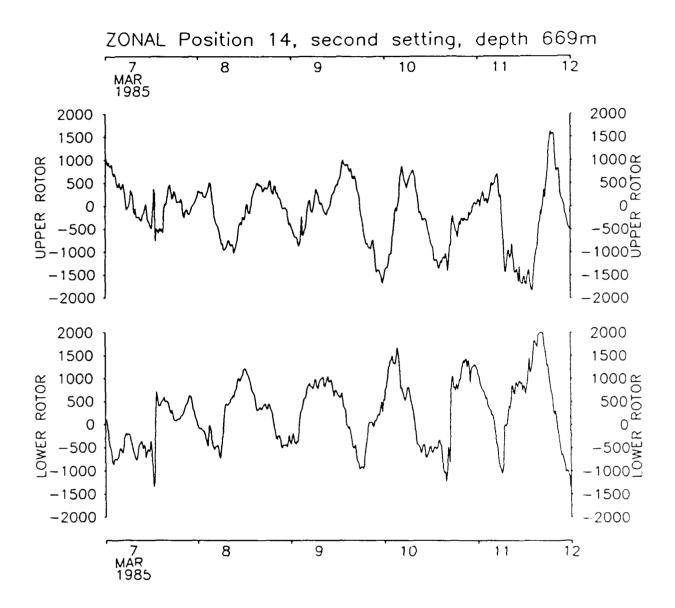
Fig. 23 A VMCM data record from the second year's ZONAL deployment (1984-1985)
